Eastport Downtown Piers Safety & Maintenance Issues

A Photographic Report

Prepared by Robert Godfrey

2020 August 4

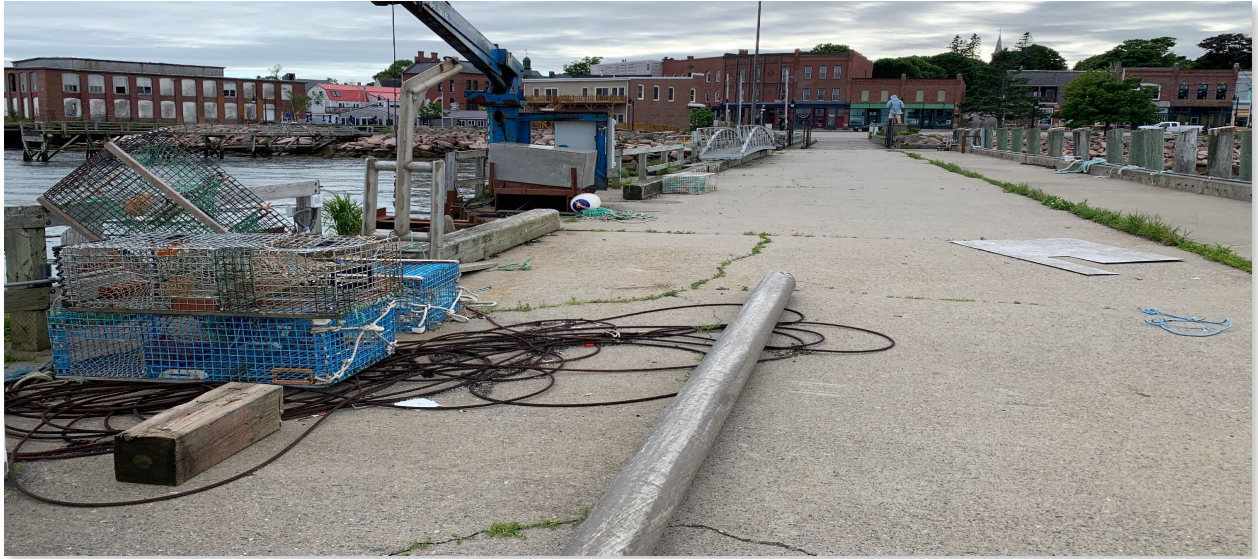
Photograph above is from March 2022. The fallen pole was not removed until four (4) months later.

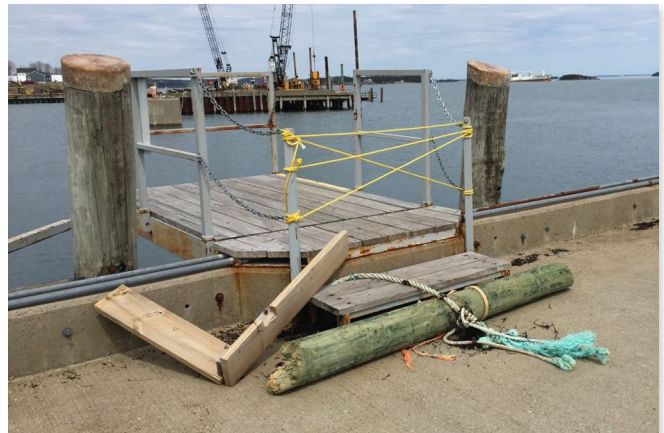
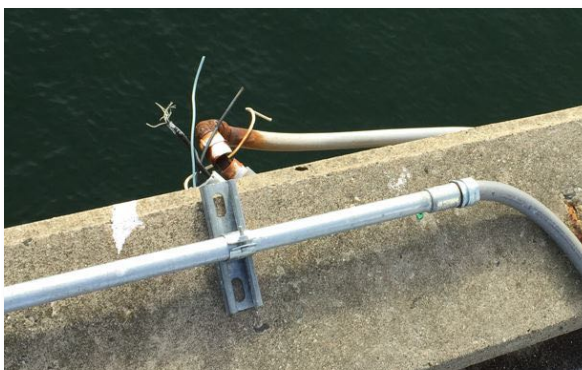
Image to the right is from April 2016. Eventually, after reporting, the rope was replaced with chain and the refuse was removed.

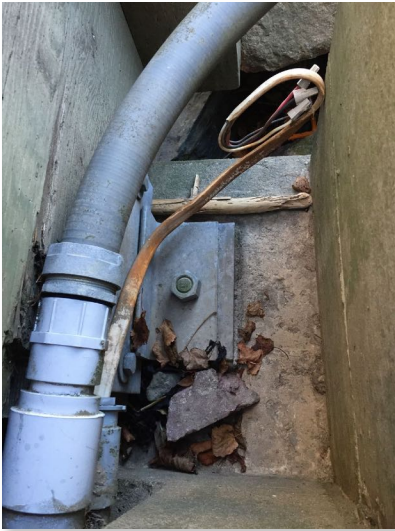
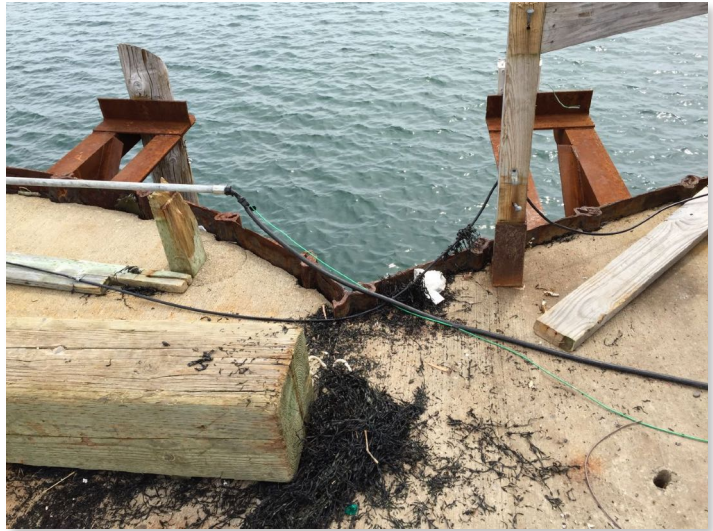
The exposed wiring (left) is from January 2016. After reporting the issue the wiring was eventually removed.

In late 2019, electric wiring at the Fish Pier base (above left) existed *outside* an enclosure. The exposed wiring and conditions (above right) were reported on 2016 April 22, and were eventually fixed.

Suggestion: Whether wiring is “live” or not, and since wiring may become electrically charged in the future, comply with good electrical practices and keep all wiring within approved enclosures, with appropriate wiring connections.

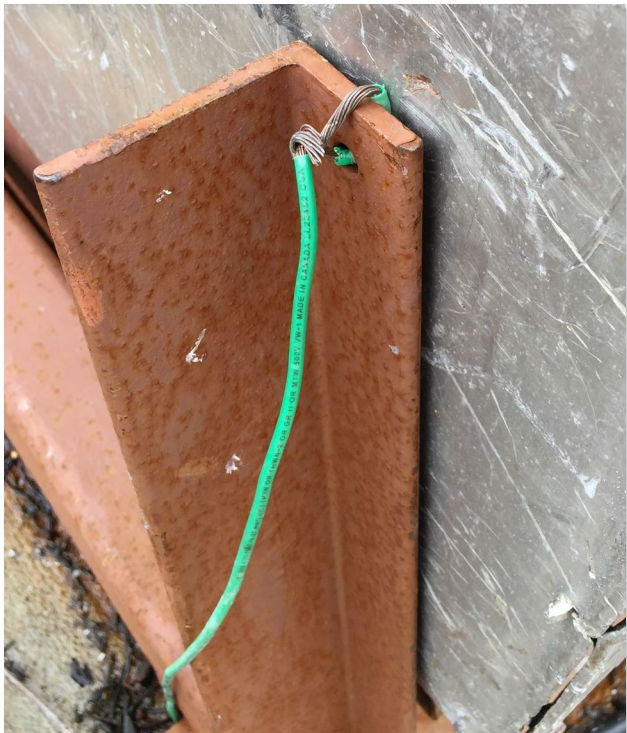
This improper ground wire connection at the Fish Pier crane is from March of 2016.

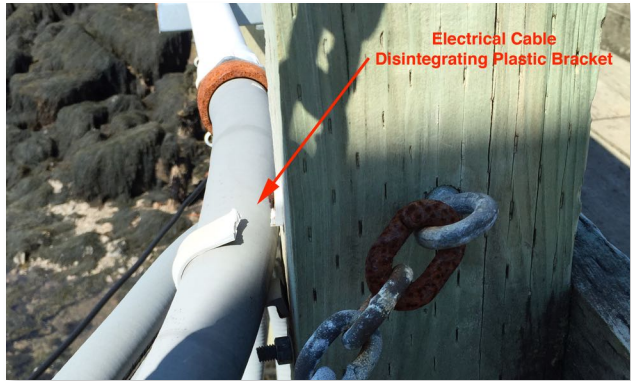
There are a great number of plastic conduit brackets on the south side of the Fish Pier. Many broken brackets remain, even while absent any conduit. The plastic disintegrates, dropping plastic into the water, adding to plastic pollution in the sea, endangering sealife.

Suggestion: Remove all plastic brackets, and replace with metal brackets.

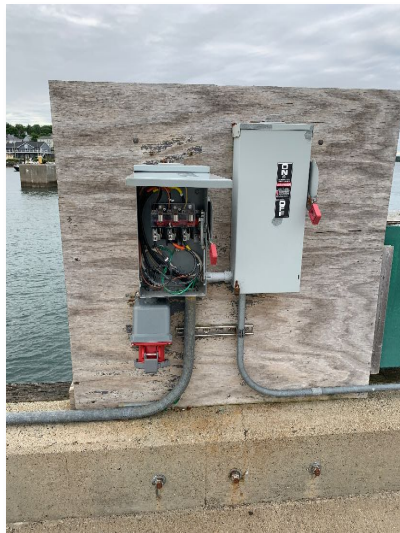
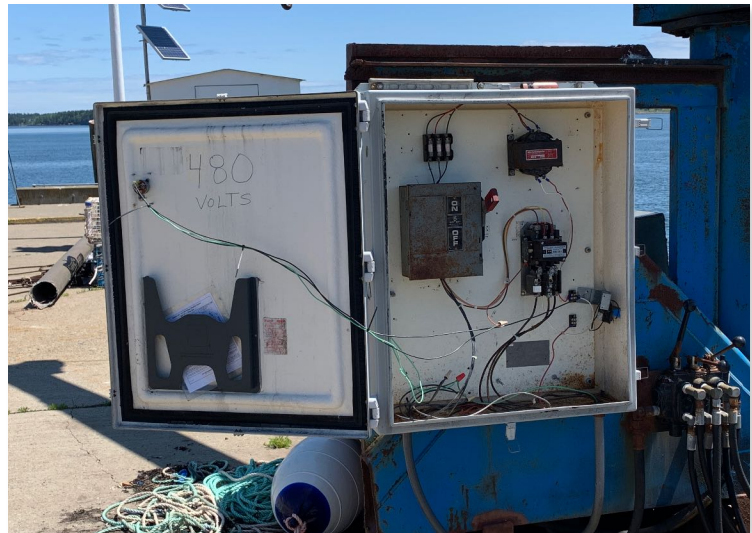
Several incidents of unlocked circuit boxes have occurred since 2016 (box on left photo was 2022 Jun 25); crane box (right) was unlocked from at least 2022 May 20 to Jun 5). Recently, the box on the left has had a padlock reinstalled. After escalating the issue, **the box on the right was finally replaced** on 2022 August 1st or 2nd with one identical to the Municipal Pier's south crane circuit box, illustrated later in this document (page 9).

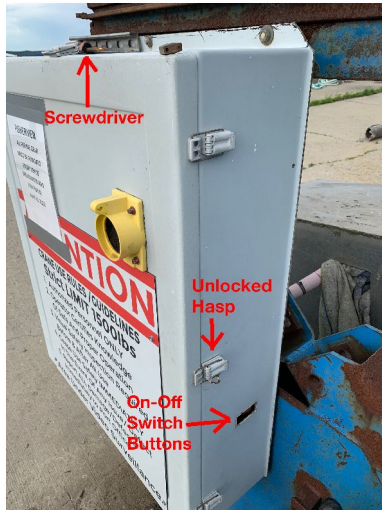
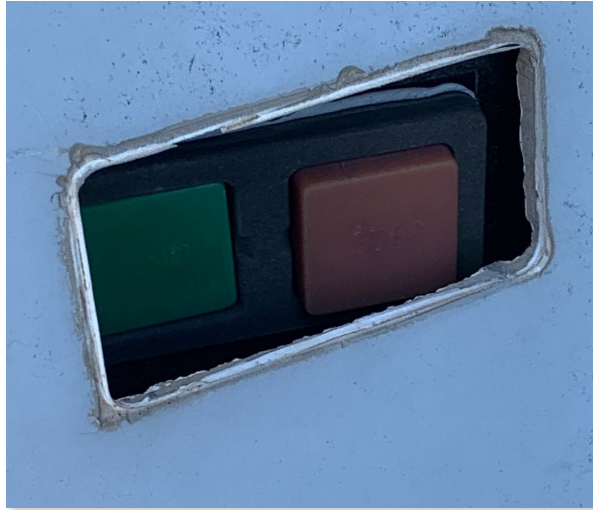
Keyswitch was being switched on and off with a screwdriver (seen atop the box) since 2021. On-off switch buttons on the bottom right side of the box (closeup view is photo on the right) were loose, pushed inside the box, allowing rain and salt spray to enter the box. This box was replaced on August 1 or 2 after the issue was escalated.

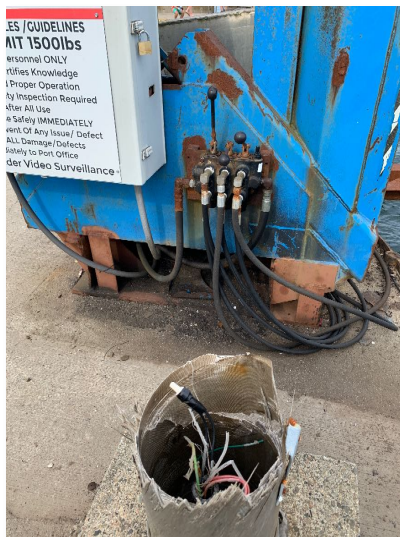
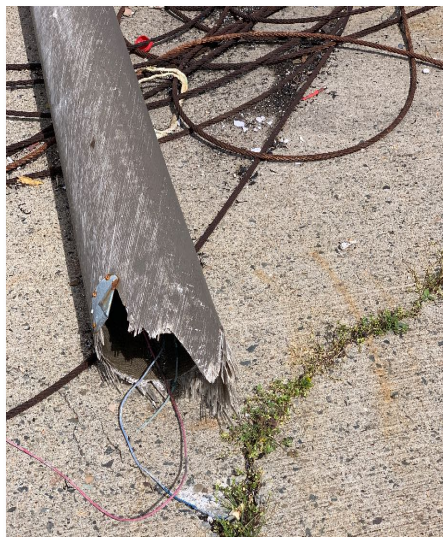
Crane operator could stumble and fall backwards onto jagged fiberglass light pole base. Also, exposed electrical wiring presents an electrocution hazard. Anyone could have impaled an ankle on the jagged end of the pole. This condition has existed from around 2022 March 27. The fallen pole was removed four months later.

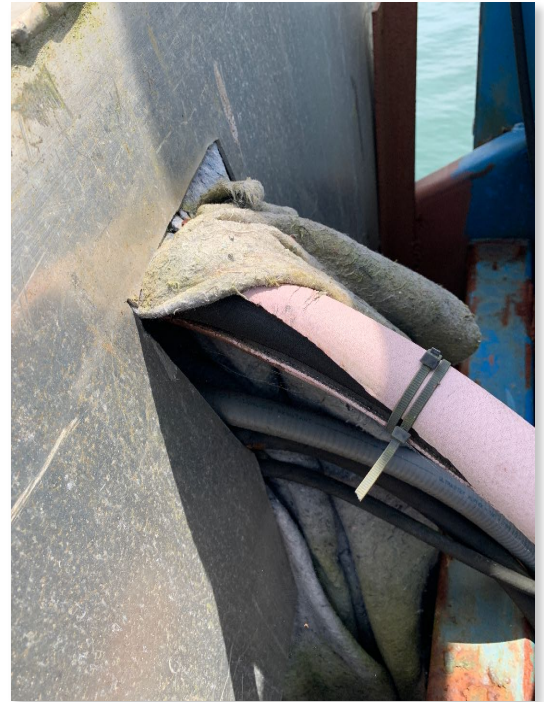
The heavy metal cover atop the crane's pneumatics has been resting atop the hoses since at least 2016, cutting into the top hose. Instead of preventing the cover from resting on, and cutting into the hoses, shoddy solutions have been substituted.

Suggestion: Add legs to the cover to keep weight and cover's edge off the pneumatic hose.

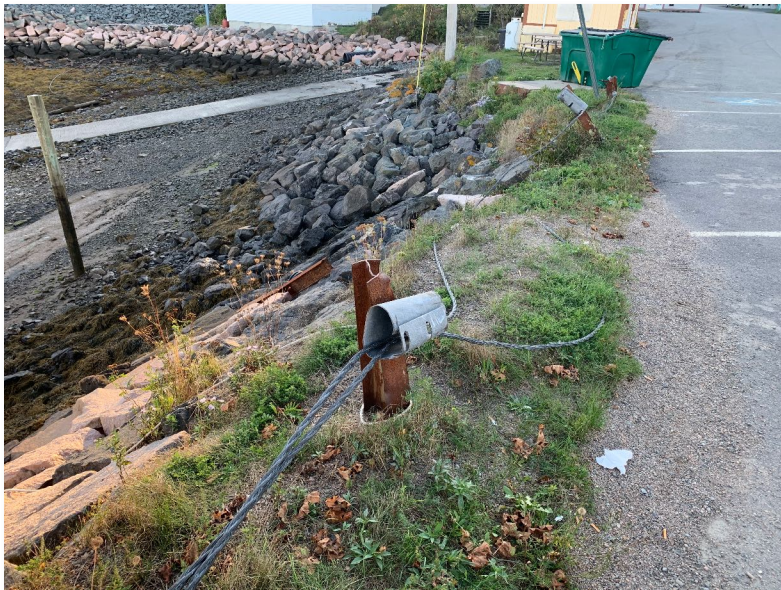
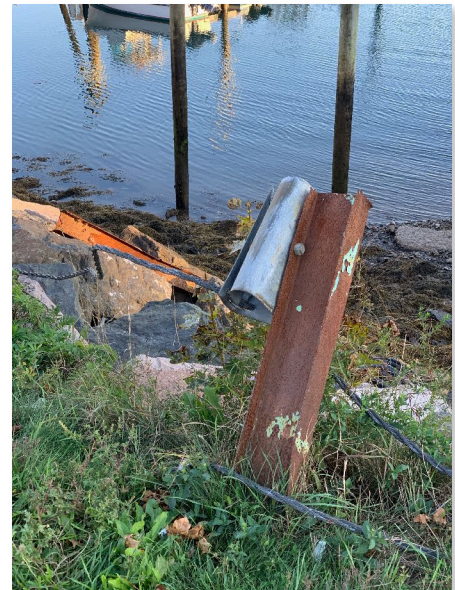
The land portion of the Municipal Pier along a dropoff has a derelict parking guardrail in serious long-existing need of repair.

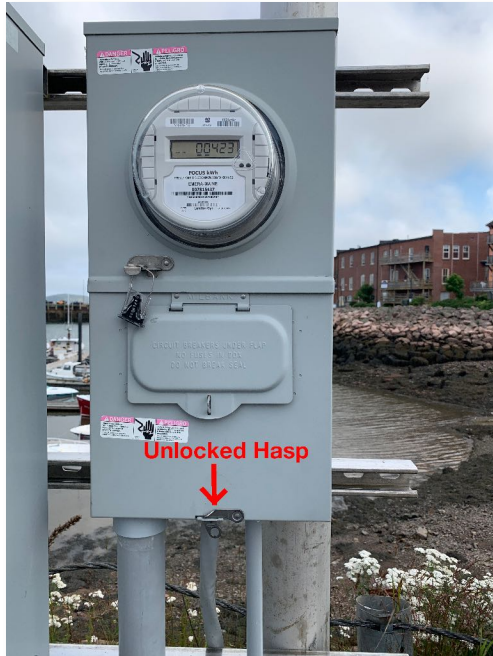
Anyone has access to the wiring inside this circuit box that has been unlocked since at least 2021.

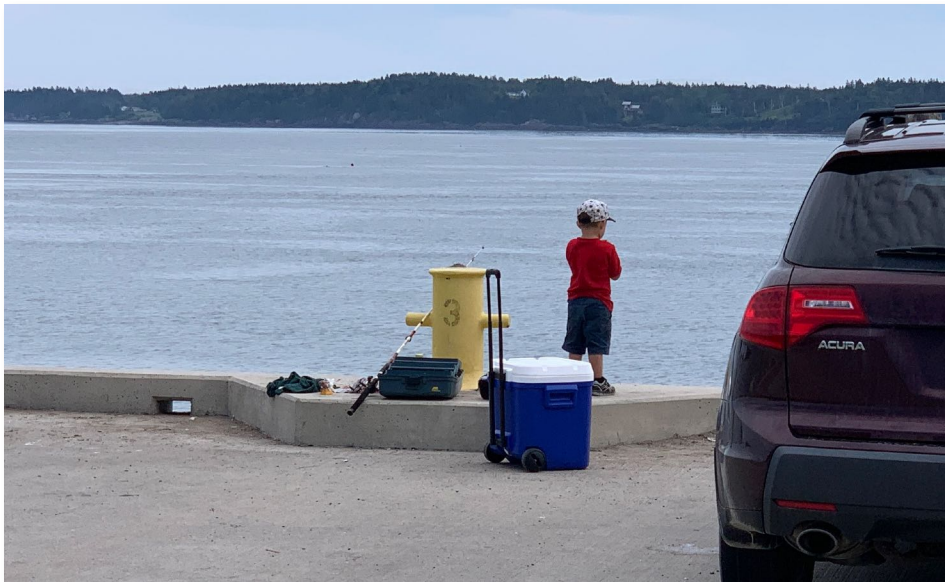
A young boy (above), and his father (obscured by car) were standing on the pier's curb while fishing, presenting a danger of falling into the bay below.

Suggestion: Paint "**Danger–Keep Off Curb**" along top of curb.

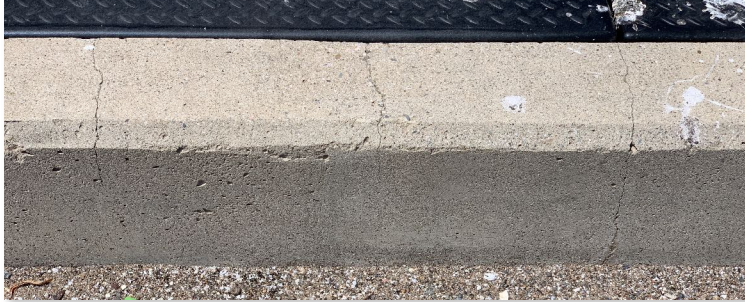
Cracked Concrete Curb every 1–4 Feet, Approximately 500 Cracks; No Expansion Joints.

Rain & winter conditions will cause disintegration of curb.

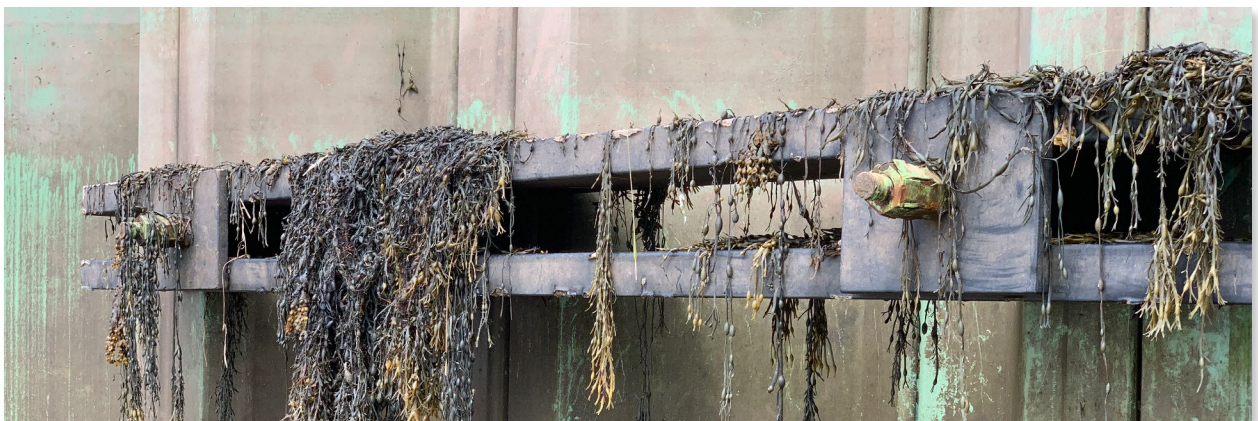
Many of the covers have fallen off (right & below), advancing corrosion of nuts and bolts holding the pier wall in place.

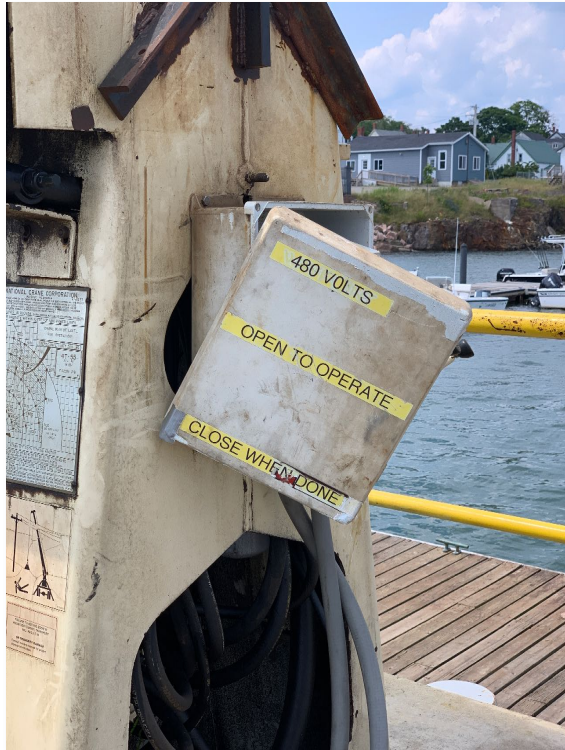
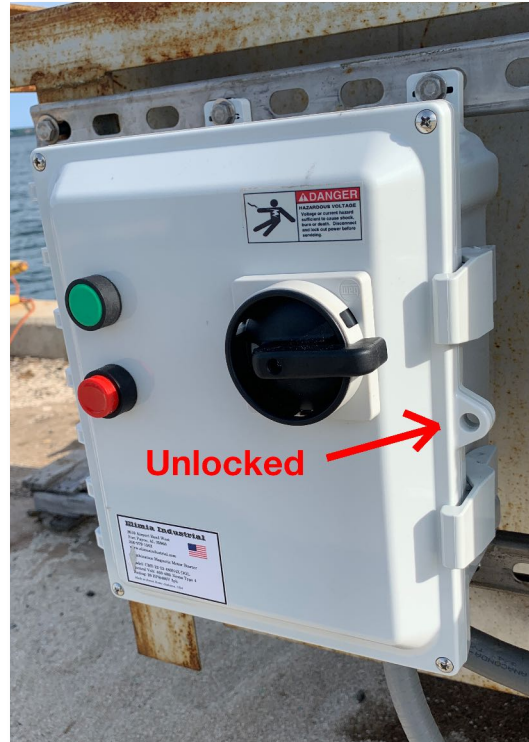
The north crane 480-volt control circuit box (above left) is in poor condition. The unlocked 480-volt south crane control circuit box (above right) is the same kind that has just replaced the 480-volt box on the Fish Pier crane (shown on pages 4 & 5).

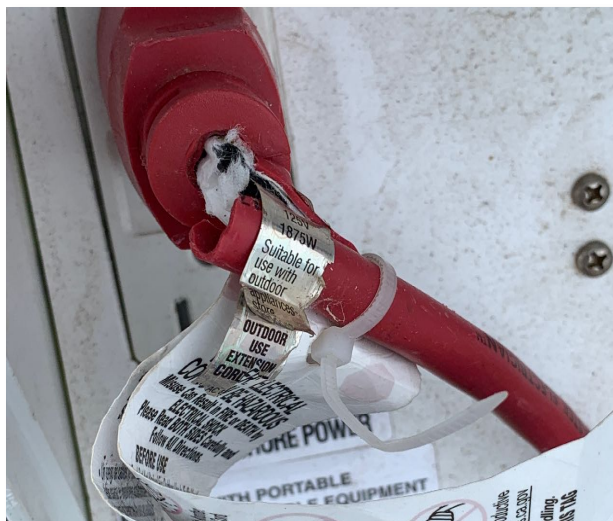
Insulation on this cable is broken down to the internal wiring. At this writing the female end of this cable is submerged along the west edge of the inner basin (see image on page 14). This condition has existed for over a month, even after informing the Eastport Port Authority director in person on 2022 July 29.

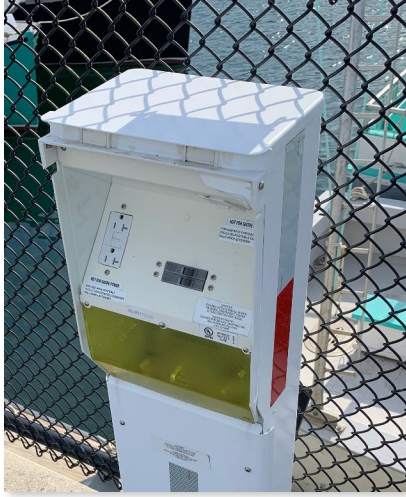
This is **one of six (6) outlet boxes that have lost their weather covers**, allowing water and salt spray to corrode plug connections and circuit breakers. They are still missing protection from the elements—some missing since a year after pier reconstruction.

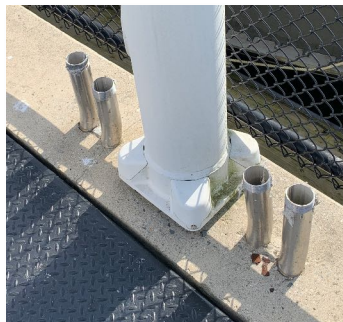
(Above right) Since pier construction, twelve (12) conduits on the Municipal Pier have never had caps installed, allowing rain, salt spray, gull guano, and refuse to accumulate inside. Duct tape had initially been used to cover the openings. Naturally, that did not last.

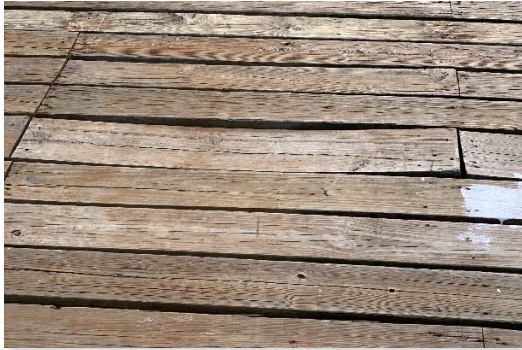
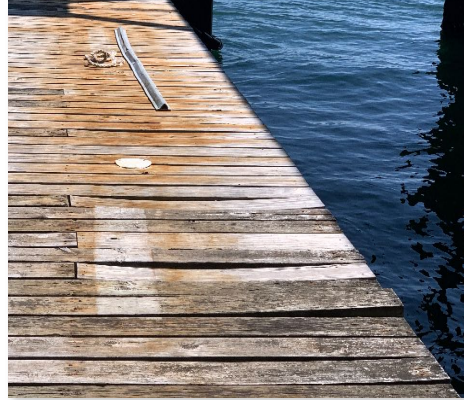
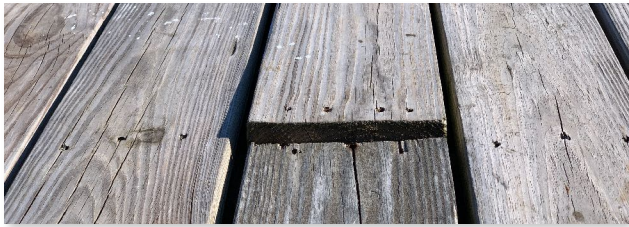
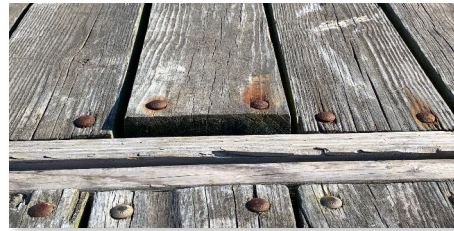
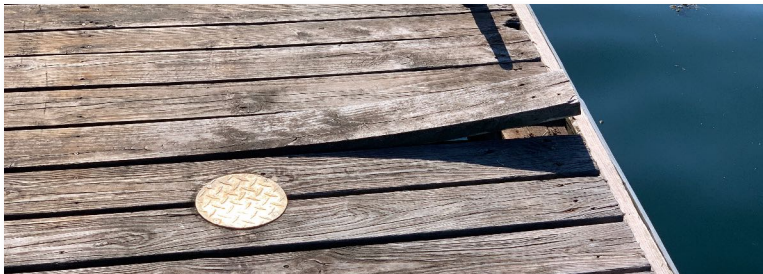
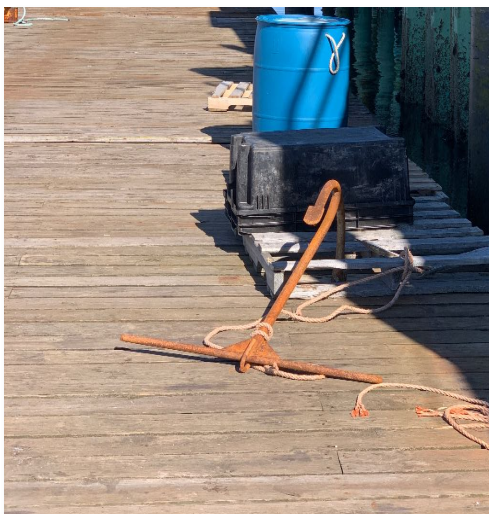
There are more such tripping hazards than shown below. These problems did not just suddenly arise, have developed over time, but have not been attended to.

On 2022 Jul 30, as a boat excursion disembarked, this writer witnessed a young boy trip on this anchor that was left on the north floating pier.

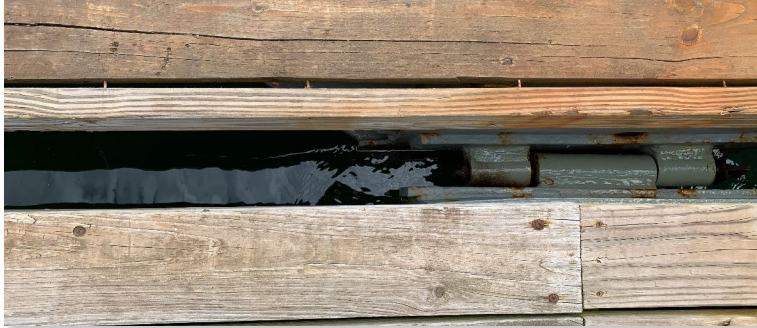
The following is a gap between floating pier segments, presenting tripping and sprain or broken bone hazards. It has been reported that people have gotten their feet stuck on multiple occasions.

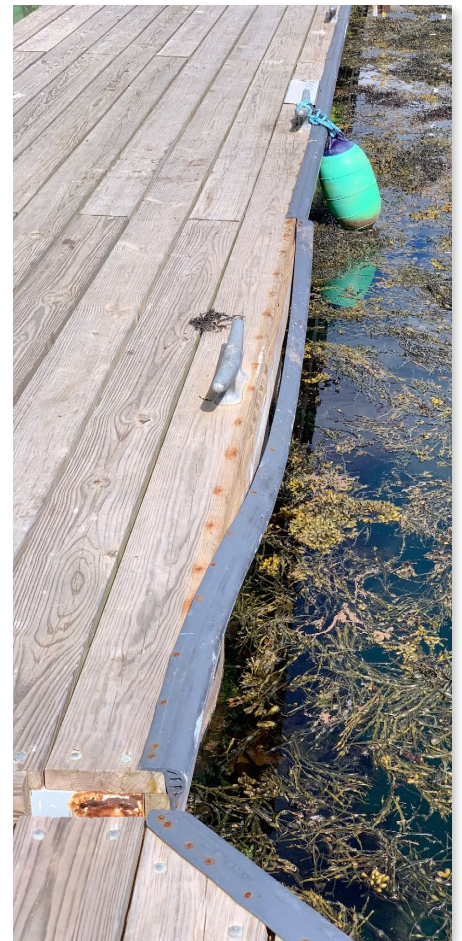
A loose edge bumper (right) on an inner basin float may eventually fall in the water, causing pollution and losing protection for any docked boats.

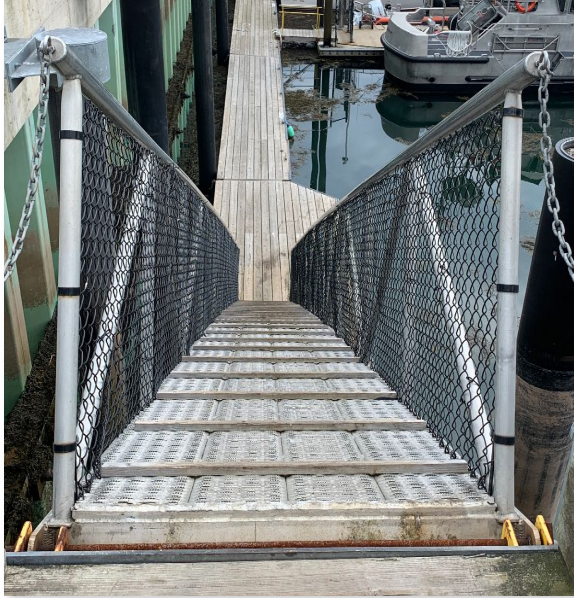
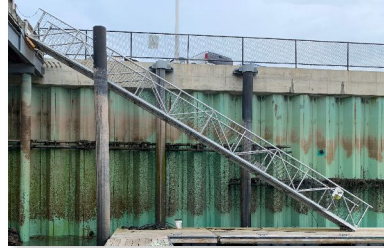
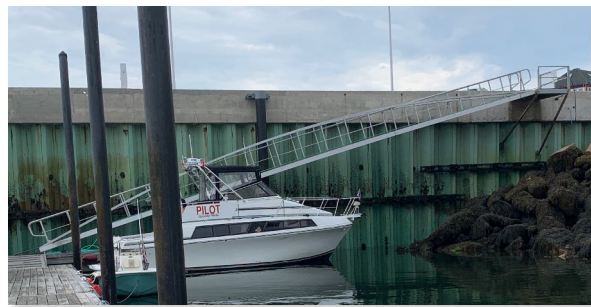
The inner basin ramp (above left and top) is considerably shorter than the north floating piers ramp (above bottom right), making the inner basin ramp very steep at low water, and dangerously slippery when wet from rain. Winter conditions make it even more hazardous. **Suggestion:** Extending the inner basin ramp would make using the ramp much safer.

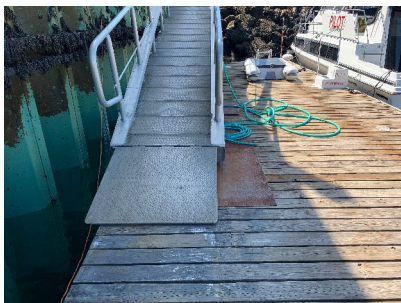
Many people of all ages use this ramp to board and depart whale watching and fishing excursions, as well as pleasure boaters and fishermen. The end of ramp sometimes moves sideways at the bottom due to the length of the ramp and the changing tide, and can present the pictured falling and drowning hazards.

Suggested Solution: Add a rail along the inside of this section of the floating pier. The rail would guide the bottom of the ramp away from water's edge as the tide changes, protecting the public from falling into the water.

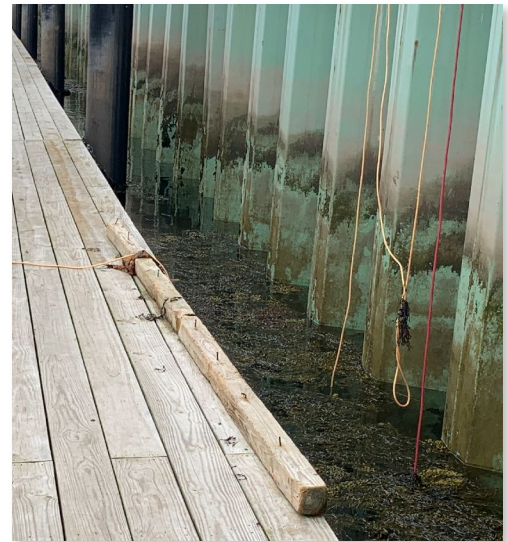
Multiple non-marine quality electric extension cords are partially immersed in the water due to dropping straight down from the Municipal Pier into the saltwater between the main pier and the floating pier.

The red cord (photo at right) has two serious problems: **the female receptacle end is completely submerged, and the male end that is plugged into the outlet box on the Municipal Pier has broken insulation**, as shown previously in this document (page 9). The Port director was informed of this on 2022 July 29.

Suggestion: Require and enforce use of marine-grade electrical cords.

Suggestion: A bracket at each outlet station extending out over the floating pier would enable electric cables to go from the outlet box, over the bracket, and drop directly onto the floating pier, avoiding the water even with the changing tide.

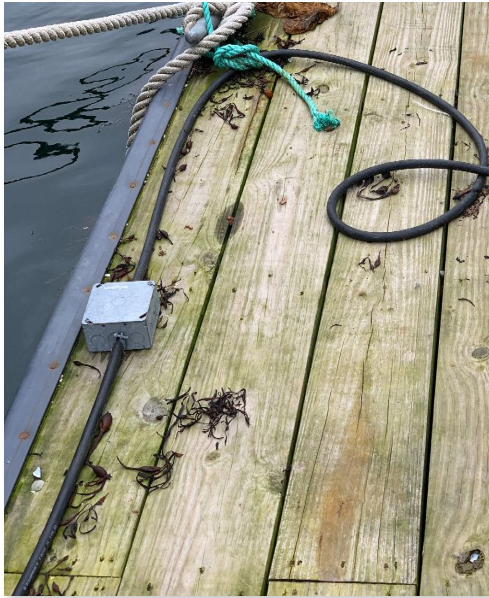
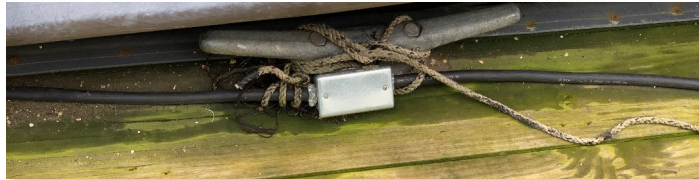
Although these may be marine-grade electric cables, the non-marine, non-waterproof junction boxes present fire and electrocution hazards.

Suggestion: Require and enforce use of only marine-grade cables, splices, and connections.
