Eastport Downtown Piers Safety & Maintenance Issues

A Photographic Report

Prepared by Robert Godfrey

2020 August 4

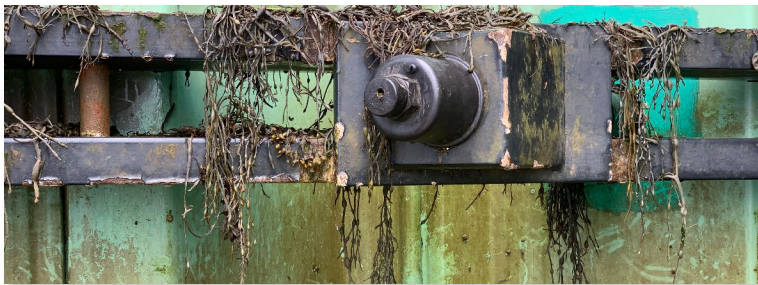
The following image shows a bolt & nut cover properly in place:

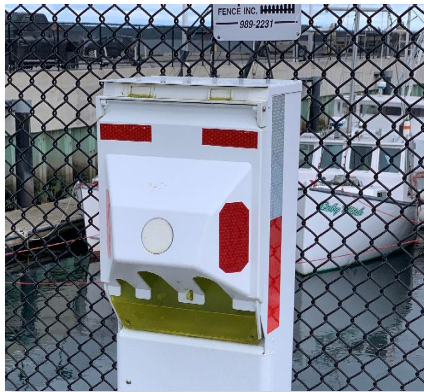
This outlet box has an intact weather cover, protecting outlets and circuit breakers from rain, ice, and salt spray. All outlet boxes should have this weather cover protection

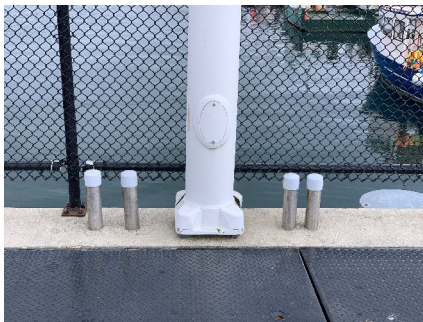
Shown (above left) are conduits on the Municipal Pier with caps in place.

(Above right) Since pier construction, twelve (12) conduits on the Municipal Pier have never had caps installed, allowing rain, salt spray, gull guano, and refuse to accumulate inside. Duct tape had initially been used to cover the openings. Naturally, that did not last.

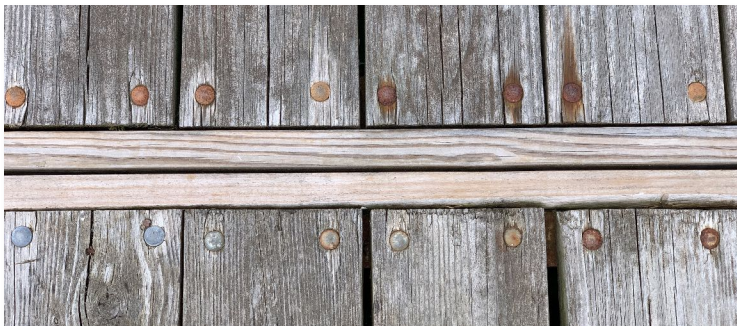
Below left shows how two segments of floating pier are properly constructed to prevent feet from getting caught in the gap between segments.

A loose edge bumper (right) on an inner basin float may eventually fall in the water, causing pollution and losing protection for any docked boats.
