# **Addendum to Eastport Downtown Piers Safety & Maintenance Issues A Photographic Report**

**2023 July 21**

## Addendum to Eastport Downtown Piers Safety & Maintenance Issues

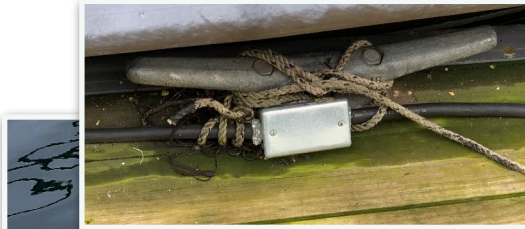
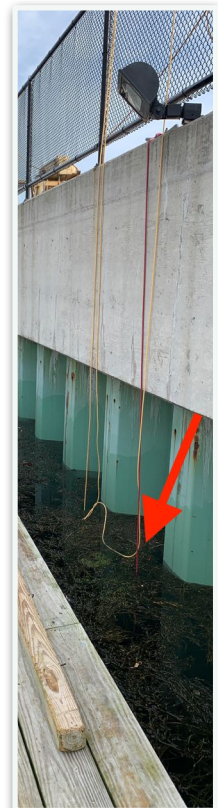
- **The damaged red electrical cord** leading from a shore power outlet on the Municipal Breakwater, was then unplugged from the outlet, and wrapped around a cleat near the outlet (left, 2022 Aug 12), **but with the female plug still submerged in inner basin seawater for months** (right, 2022 Oct 7; report, pg 14).

**In 2023 May, instead of removing the cord, the female end was removed from the water, but then the male end—with broken insulation— was again plugged into the shore power outlet** (left, 2023 May 22). **The tag on the cord states “Always Store Cord INDOORS”, and not for use in wet conditions.**

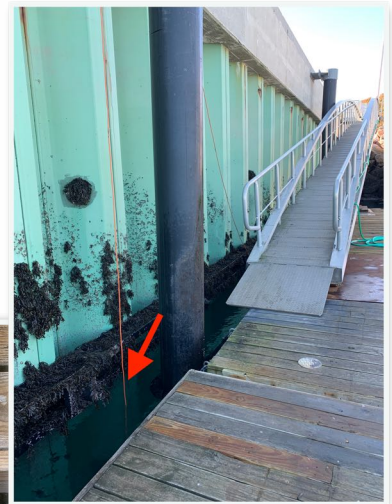
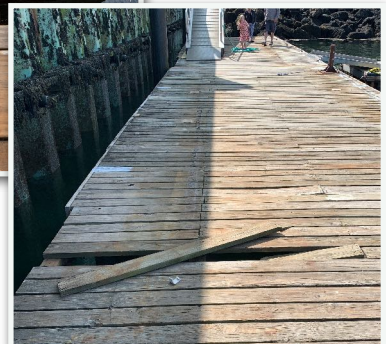
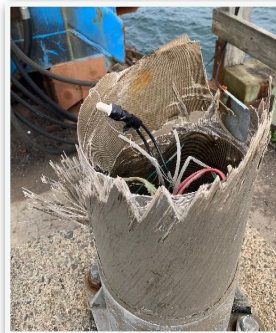
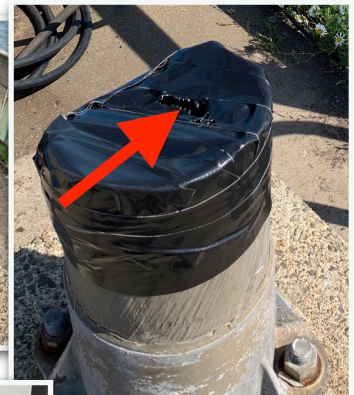
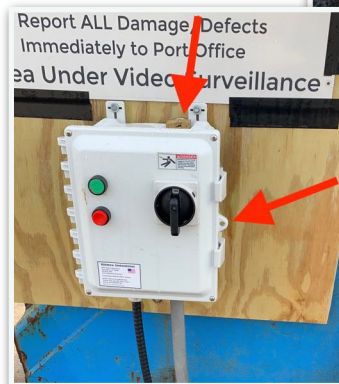
After the report was published on 2022 August 4, **an additional red electrical cord's submerged female plug was found** at the north floats near the bottom of the ramp, likely corroding the plug components, **creating a potential electric shock and fire hazard** (right, 2022 Oct 22).

- This writer was informed that volunteers nailed down loose planks on the floating piers in the inner basin and on the north floating piers; however, **hazardous gaps between multiple sections of pier remained** (near right, 2022 Aug 1) In 2023 May many—though not all—of the loose boards had been either replaced or nailed down; **however, a broken deck plank existed** (far right, 2023 May 29).;

- The broken light pole lying on the Fish Pier (pg 5 in report) was removed **after four months**, and the remaining jagged base with exposed wiring (near right, 2022 Jun 25) was taped over; however, shortly after taping, **someone punched a long hole in the tape, again exposing the electrical wiring and conduit to rainwater, snow, and sea spray** (far right, 2022 Aug 21). The hole remains,
- The Fish Pier crane **480-volt circuit box** (report, pg 4) was replaced in early August (near right, 2022 Oct 7). Note the **unused padlock sitting atop the new switch box**. The box

**remains unlocked. as does the south crane box on the Municipal Breakwater** (above, far right, 2022 Jul 5; report, pg 9) as of this writing. **(The boxes display stickers stating "HAZARDOUS VOLTAGE".)**

**Inexplicably, the Port Authority consistently refuses to secure high-voltage (480-volt) boxes with padlocks.**

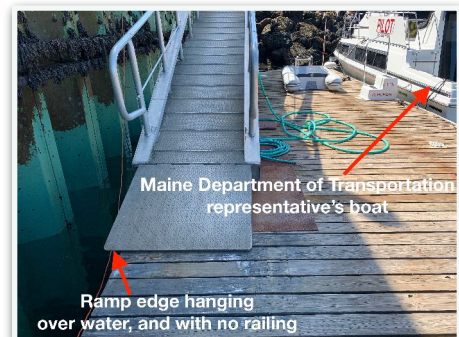
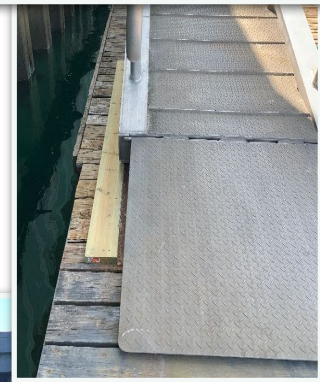
- **Multiple hazards** as **cruise ship** boat-excursion visitors arrive at north floats (right, 2022 Oct 7):

1. **Red electrical cord female receptacle is submerged in seawater** (right). Cord was unplugged and removed from water sometime prior to 2022 Nov 5.
2. **Slippery ramp from dew, with no railing on the last ramp section. This writer observed one person who—with difficulty, had just exited the ramp—tell her companion, “There’s a lawsuit waiting to happen”;**
3. **Ramp extends partially over water** (fixed with wooden cleat in 2023, below right); **still, there is no railing on the last section of ramp.**

Note: Maine Department of Transportation’s representative on the Eastport Port Authority Board berths his boat at a slip within a few feet of the ramp (above right, 2022 Jul 25); thus, he would have passed the aforementioned hazards when going to and from his boat.

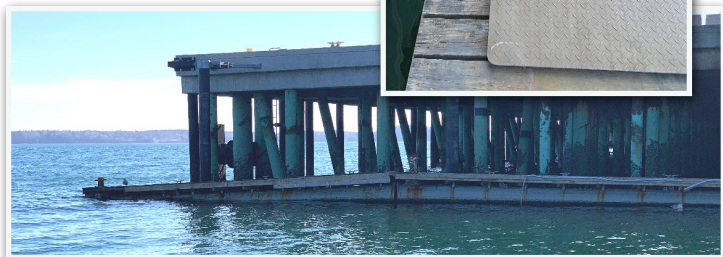
- **The southeastern portion of the north floats lost buoyancy,** causing the east end of the floating pier to dip close to the water’s surface, and lifting the other end of the section out of the water, (2022 Oct 22). It was repaired sometime prior to 2022 Nov 5.

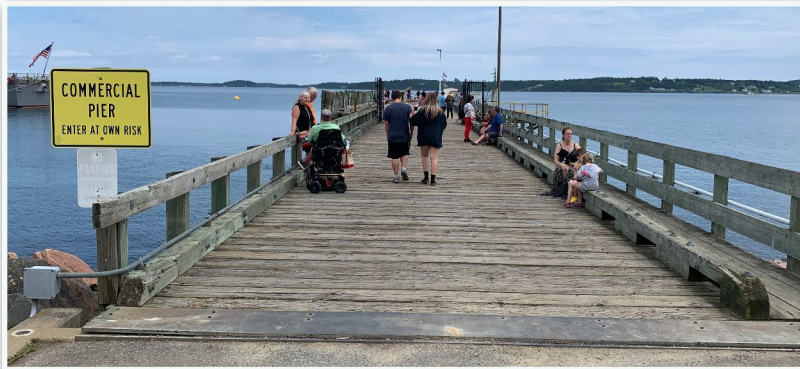
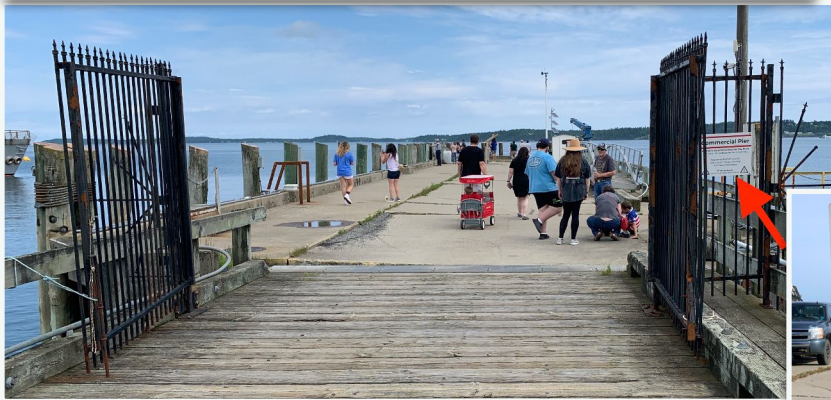
The entrance to the Fish Pier has a sign stating **"ENTER AT OWN RISK"** (left).

There is also an unobtrusive sign on the right-hand gate at about halfway onto the pier indicating **"No Public Admittance ..."** (below).

The prohibition is in small type on a sign away from the open entrance.

**The first sign approves entry at one's own risk, so the public enters, not noticing the obscure "No Public Admittance".**

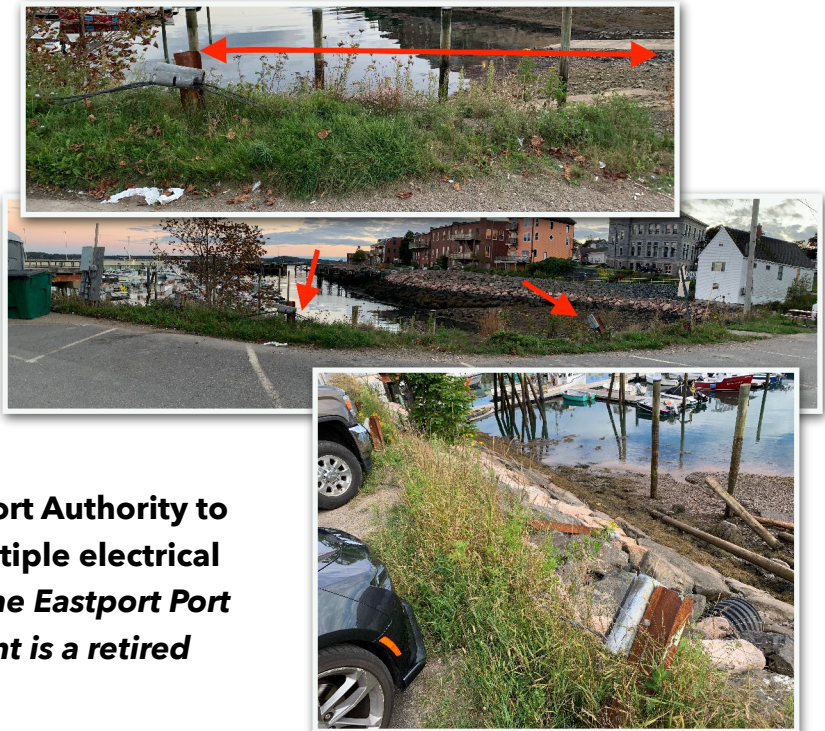
**The safety cable along the parking spaces drop-off along the approach to the Municipal Breakwater has been in disrepair or missing for years** (photos at right, 2021 Oct 4).

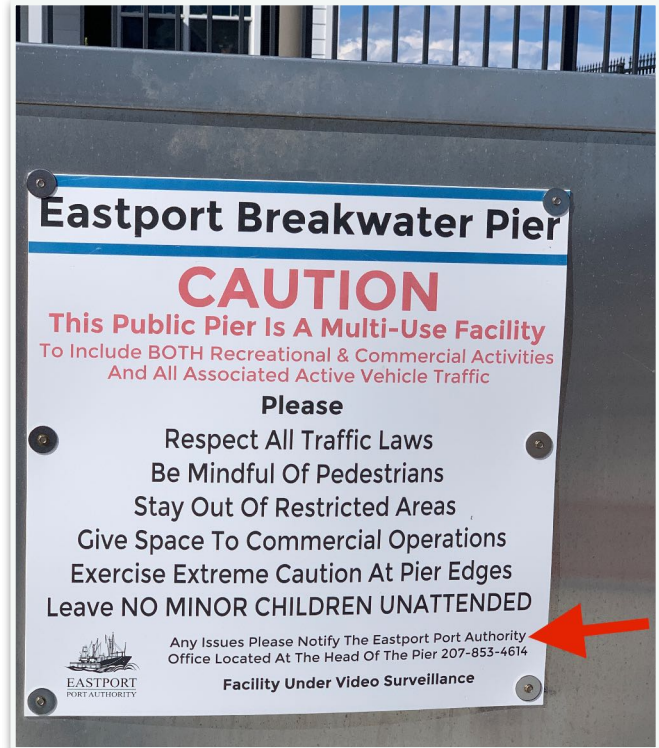
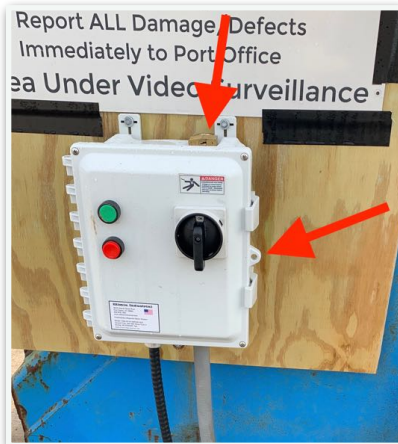
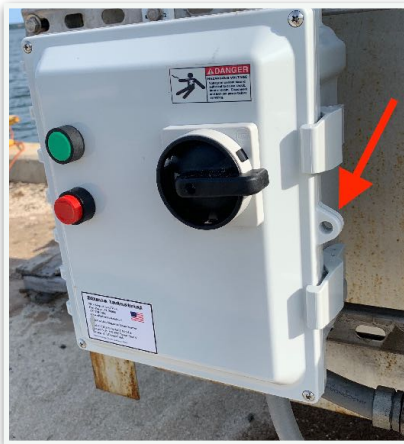
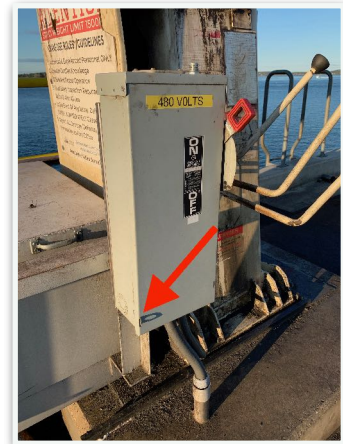
A sign posted along the approach to the Breakwater Pier (right). The Eastport Port Authority does not take seriously its own request for the public to report ***“Any Issues.”***

*The Eastport Port Authority persistently refuses to lock the three cranes’ 480-volt circuit boxes, providing hazardous access to anyone. One box, replacing the defective one on the Fish Pier (below left) has had an unused padlock sitting atop it since it was installed in 2022. Also, contrary to the City of Eastport Ordinance<sup>8</sup>, the cranes do not require keys to operate, giving access to anyone.*

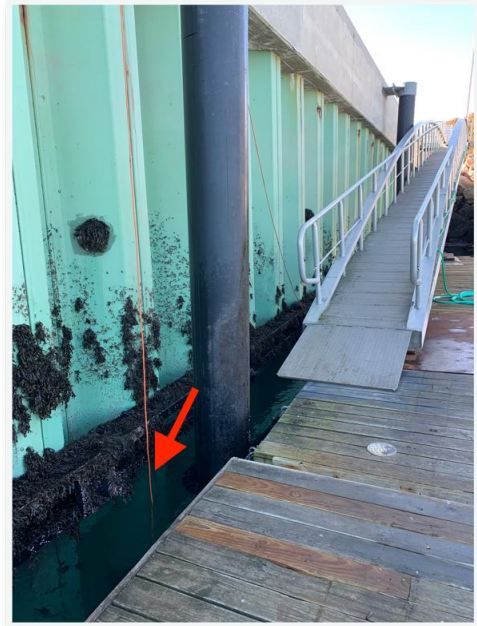
Common household electrical cords—not marine-grade—are being used to connect boats to shore power. Location of the shore power outlets, and the gap between floating piers and the breakwater where the shore power resides, results in the ***electrical cords trailing in saltwater***. In two cases, the female plugs of the electrical cords have been submerged in saltwater—one cord ***for months***. Such conditions create electrocution and fire hazards, endangering people, the piers, and berthed boats.

**Adding a non-conductive power cord support bar between pilings alongside the Breakwater Pier (above right) would allow power cords to drop down directly onto the floating piers without being partially immersed in seawater.**

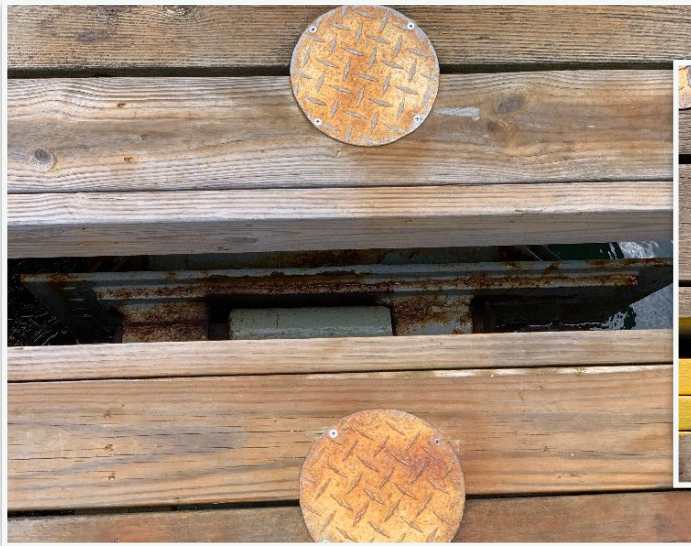
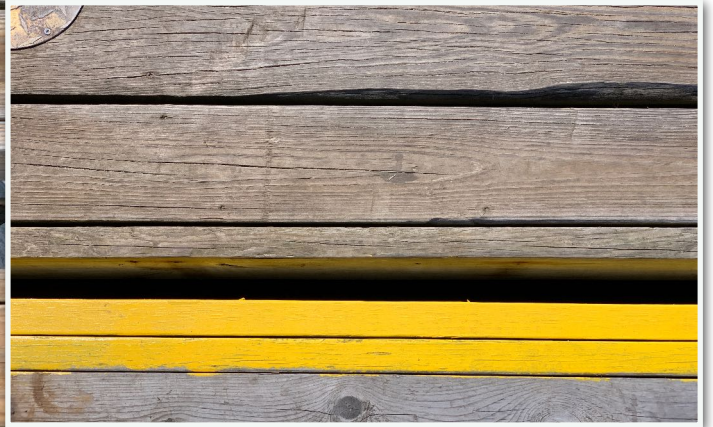
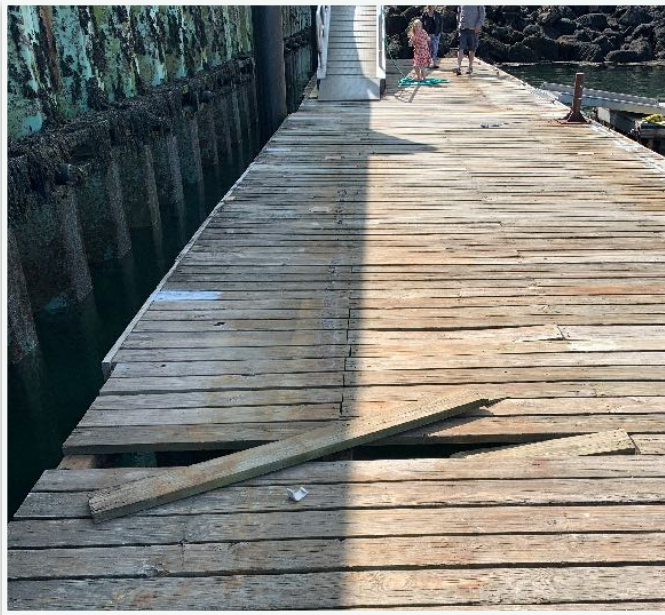
Gaps between floating pier segments present tripping hazards, with potential for sprains, broken bones, or falling into the water. After the *Eastport Piers Safety & Maintenance Issues* report, at least some gaps were reduced (below right).

Just after the north floats were installed for the 2023 season, a broken plank existed, as well as a plank bending downward, with tripping potential (bottom).

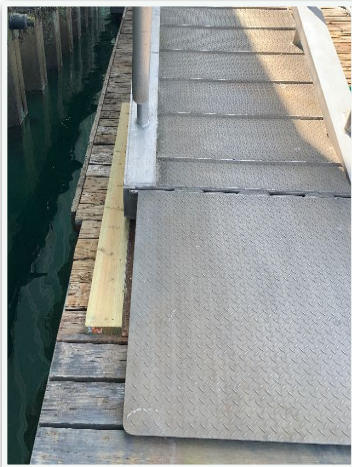
The north floats' ramp in 2022 hung partially over water, with no railing in the last few feet. After the *Eastport Piers Safety & Maintenance*

*Issues* was published, in 2023 the ramp was properly placed and a cleat was added (below) to prevent sliding over the water.

**But, still no railing at the end of the ramp.**

***Tripping hazards also existed at the end of the ramp:*** a tote box and an electrical cord. They were removed sometime near the end of the 2022 season.

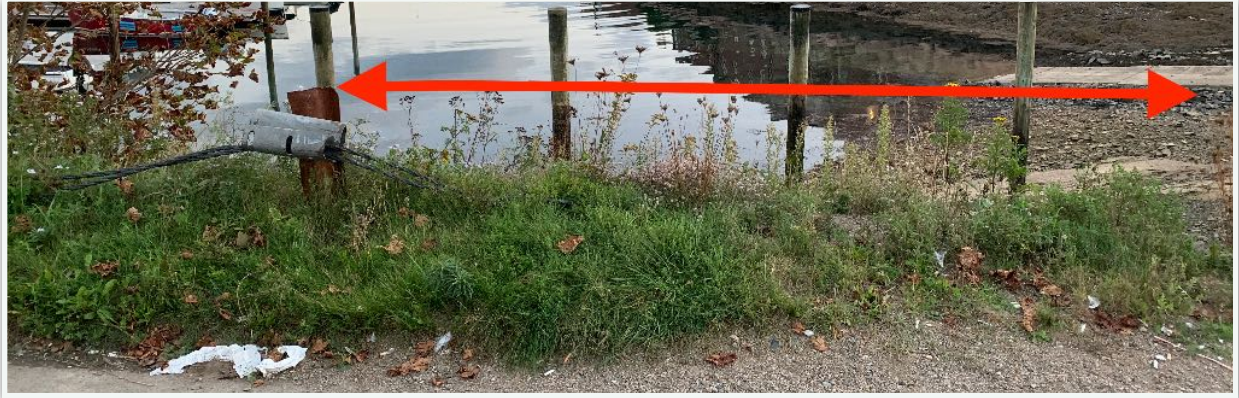
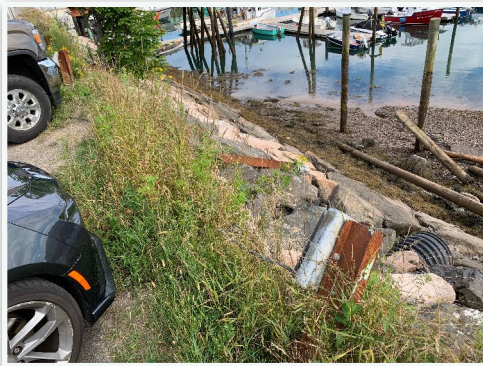
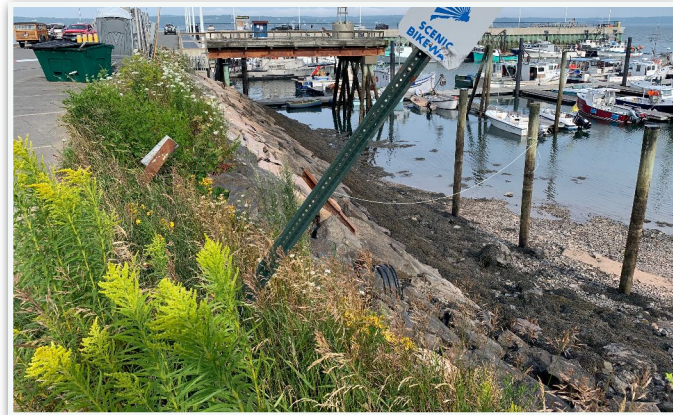
The parking guard cable along the dropoff on the approach to the Breakwater Pier has been in deteriorated and missing condition for years.

**A vehicle could roll off, into the inner basin.**

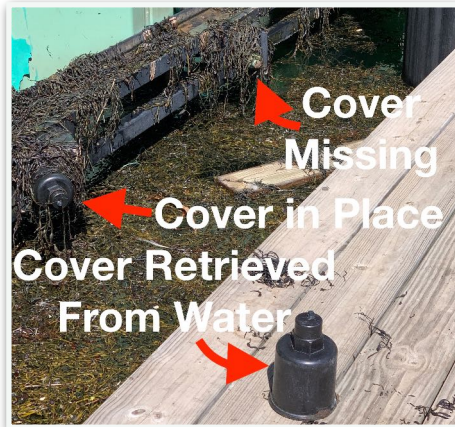
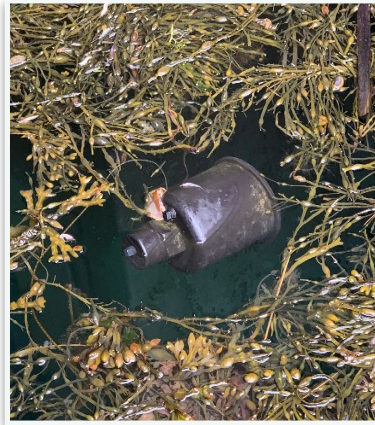
Multiple bolt and nut corrosion covers are missing from the Breakwater Pier. This writer retrieved one from the inner basin water in 2022, but it has remained on the floating pier since then.

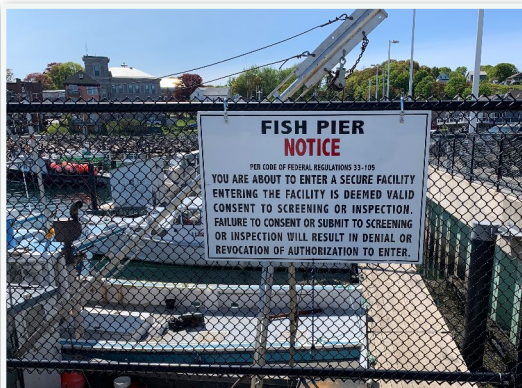
The "FISH PIER NOTICE" (left) is inappropriately posted on the Breakwater Pier.

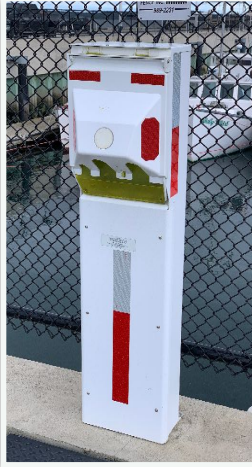
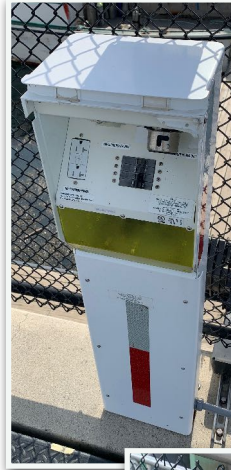
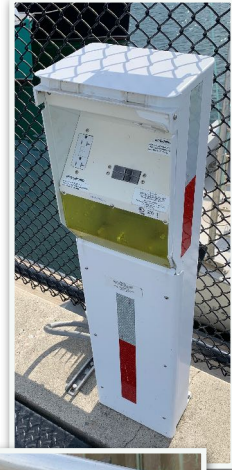
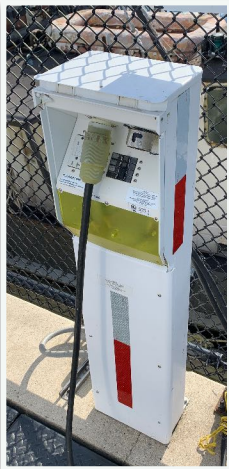
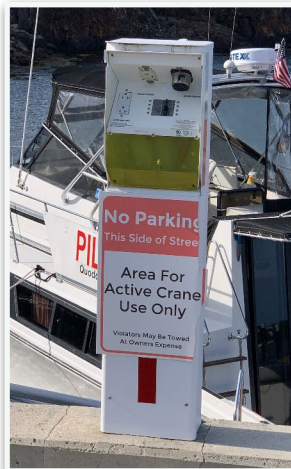
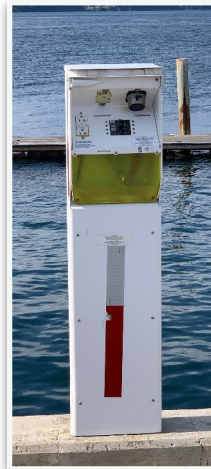
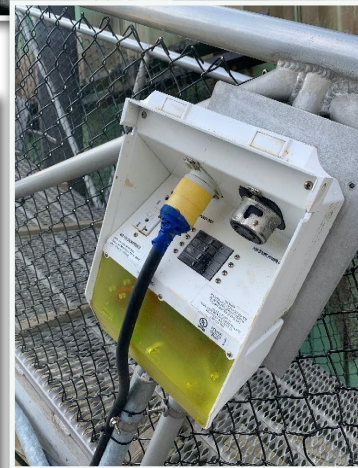
Shore power column with weather cover in place is shown (left). The others shown have been missing weather covers for years, allowing rain, snow, and salt spray to affect the electrical contacts, **presenting electrocution and fire hazards.**

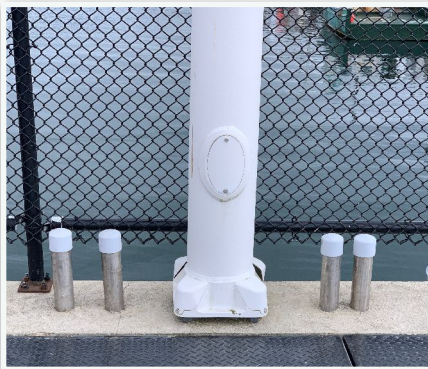
Electrical conduit caps in place are shown at left.

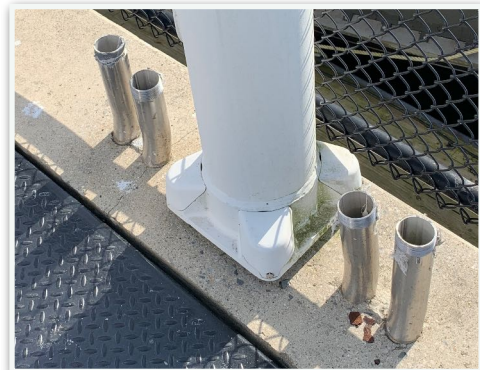
**Sixteen conduits have never had caps installed** (below right), allowing rainwater, salt spray, and guano from gulls perching on adjacent light poles to collect for years in the conduits.

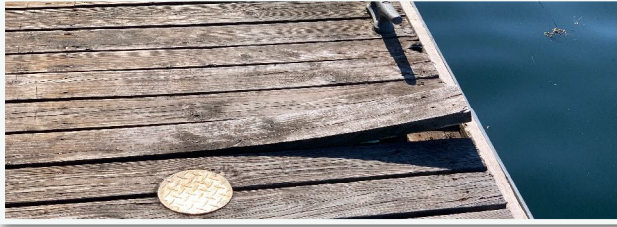
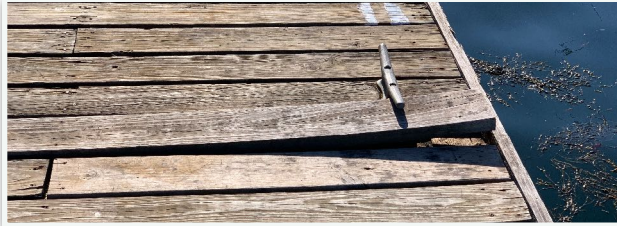
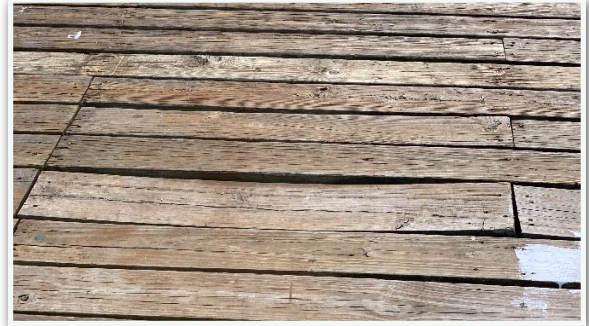
**Multiple loose planks** were reported on the floating piers in 2022, but after publishing *Eastport Piers Safety & Maintenance Issues*, volunteers repaired most of the loose planks.

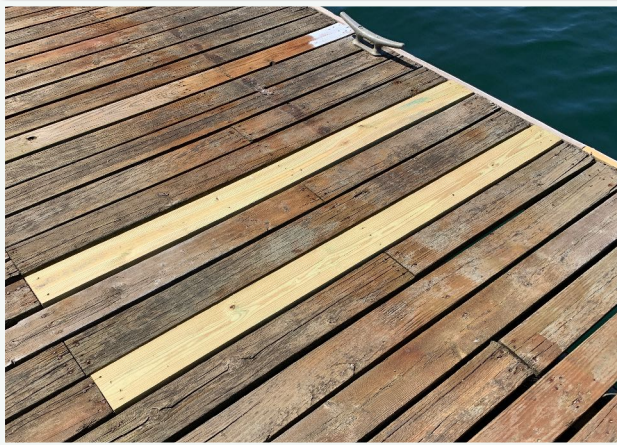
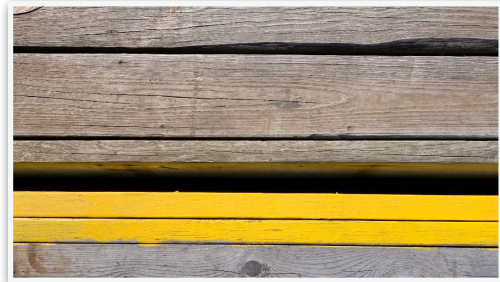
Repairs shown below were made after the 2022 season and after *Eastport Piers Safety & Maintenance Issues* was published.

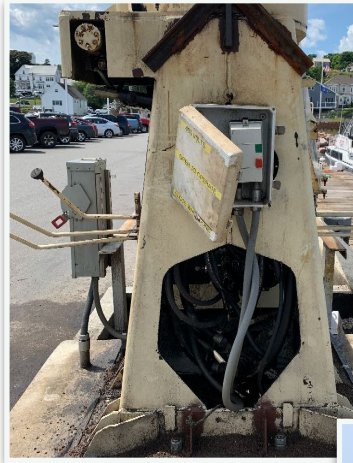
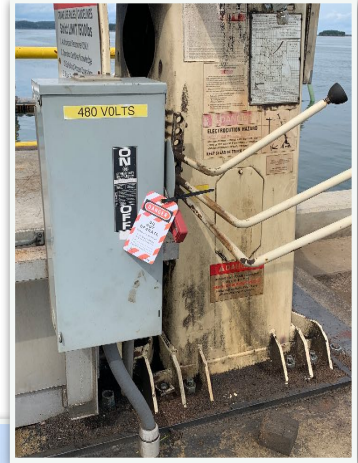
The Municipal Breakwater north crane had a control box this writer reported in disrepair to the Port Authority in 2022 (near right), and the crane was tagged out of service (far right). The control box was apparently repaired prior to Spring 2023, with the crane placed back in service; however, **the 480-volt circuit box has remained unlocked for years, giving hazardous access to anyone** (lower right, 2023 July 5).

The Fish Pier was repeatedly reported in disarray (below left, 2021 Oct 21 & below right, 2022 Apr 22).

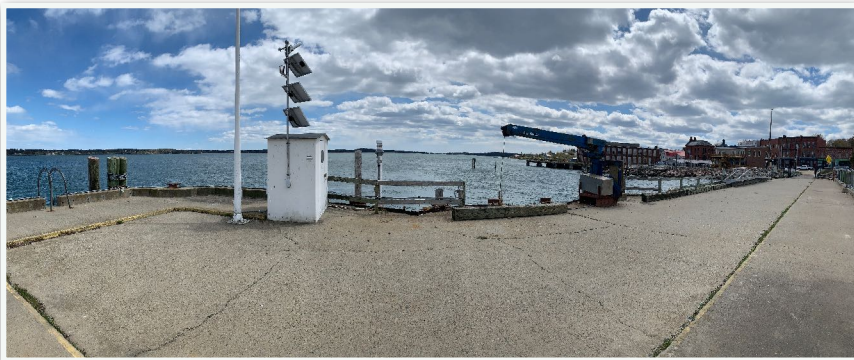
The broken fiberglass light pole was removed four months later, but the rest was not cleaned up until Summer 2023 (below).

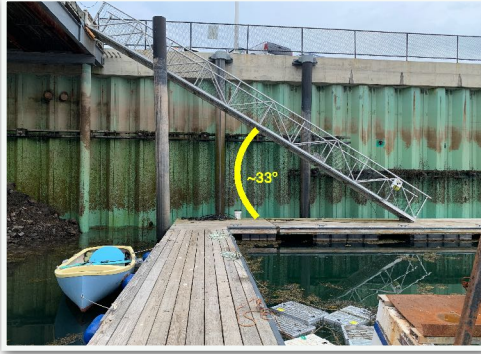
The Breakwater Pier inner basin ramp is perilously steep at low water ( $\sim 33^\circ$ ). When wet from dew or rain, it becomes dangerously slippery to users. This writer has been told that to replace the ramp with one of appropriate length would cost around \$20,000. A potential cheaper solution would be to add a box below the end of the existing sliding ramp, and add a permanent short ramp between the box and the floating pier (below).

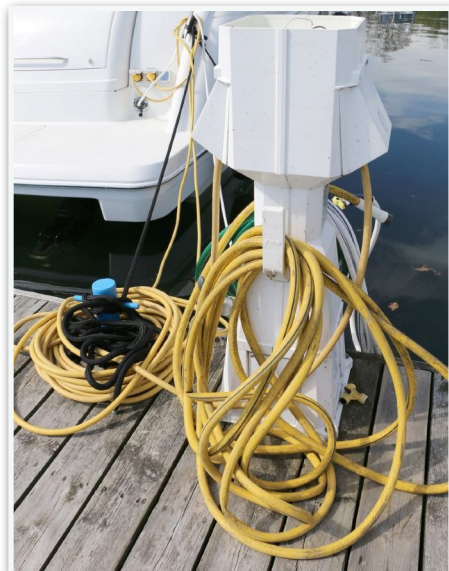
(Left) "Boaters should avoid tight coils of shore power cords. They can produce heat. **The mound on the dock is also a potential tripping hazard."**
